AIRCRAFT GROUND-FLOTATION INVESTIGATION PART V DATA REPORT ON TEST SECTION 4

W. BRABSTON and W. HILL, JR.
U. S. ARMY ENGINEER WATERWAYS EXPERIMENT STATION

TECHNICAL REPORT AFFDL-TR-66-43, PART V AUGUST 1966

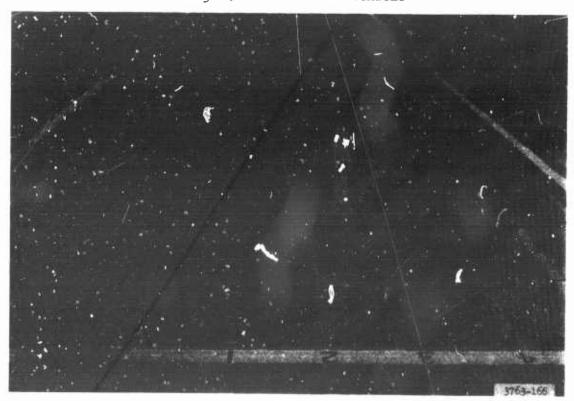
Fig 3. . Lane 7, item 1, prior to traffic

- Item 1. Fig 3 shows item 1 prior to traffic. The mat surface remained in excellent condition through 40 coverages and deteriorated gradually with trafficking thereafter. The item was considered failed due to roughness and mat deterioration at 300 coverages (Figs 4 through 7). At failure, many mat breaks and rivet failures were evident. The rated CBR of the item was 2.1.
